Ealing St Peter:

REPAIRS TO THE WEST ELEVATION

PROGRESS PHOTOGRAPHS

Taken March-October 2017

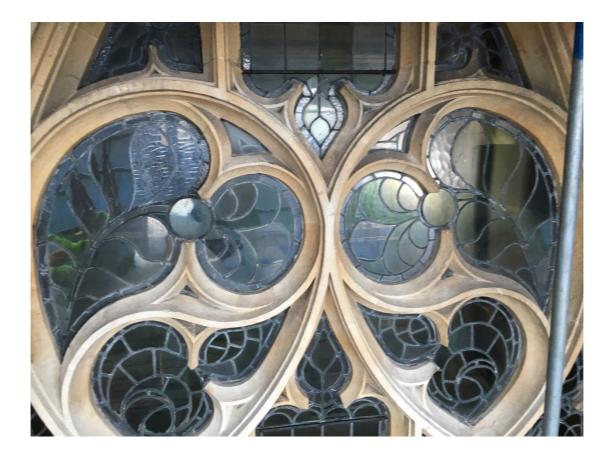
Figure 1 Typical view of tracery prior to removal showing distortion of leading

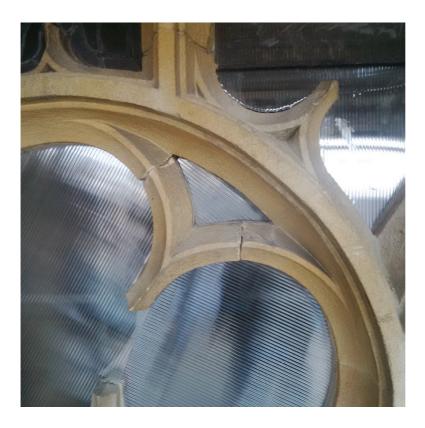
Figure 2 Typical view of tracery with temporary glazing

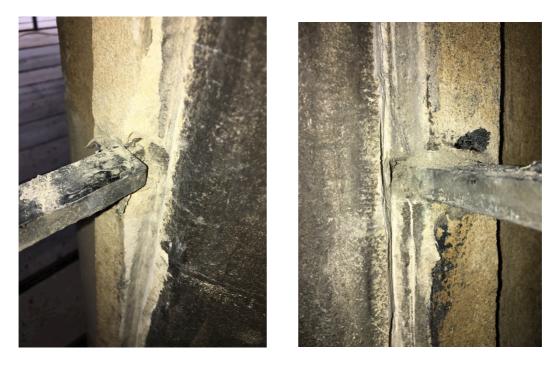
Figure 3 Typical views of ferementa showing that they are in perfect condition

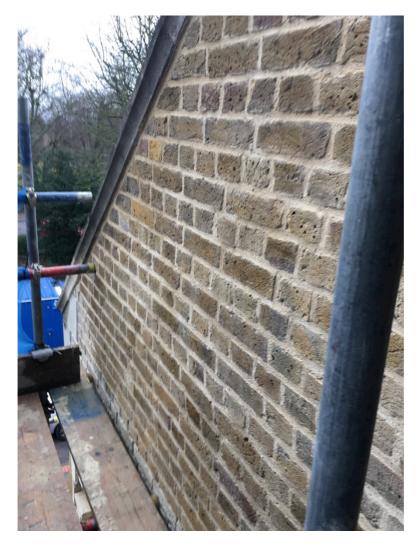
Figure 4 re-pointing to gable

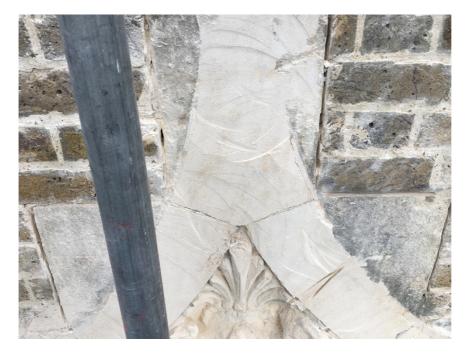
Figure 5 view showing apex of hood moulding cut out ready for replacement

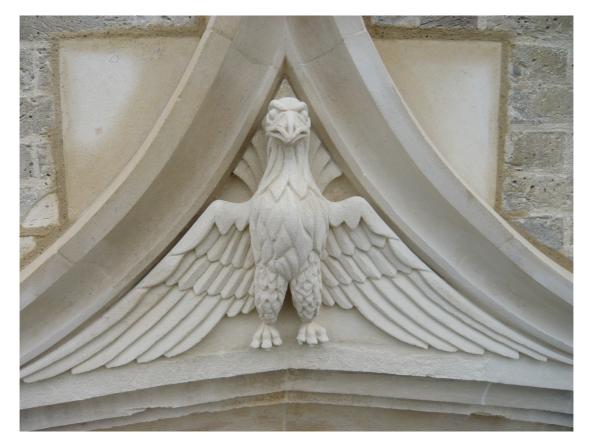
Figure 6 view showing view of completed phoenix

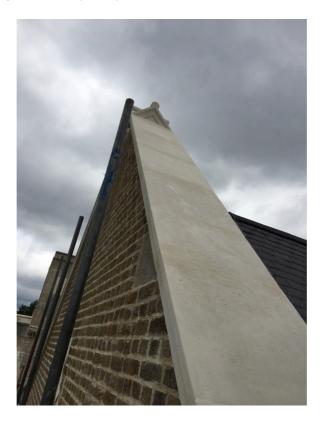
Figure 7 view showing view of new gable coping

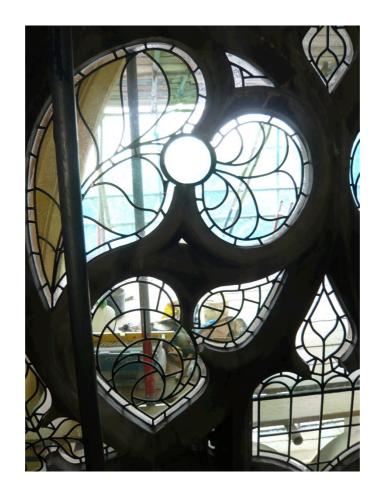
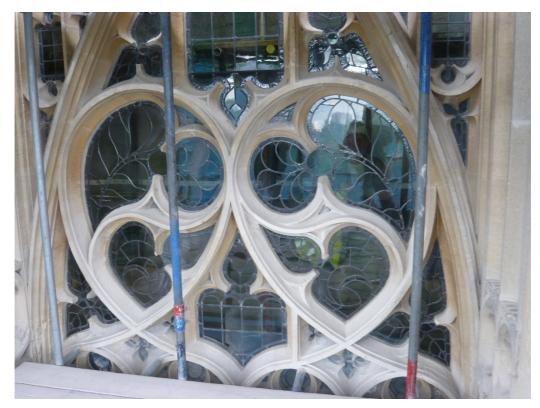
Figure 8 internal and external details of completed tracery glazing

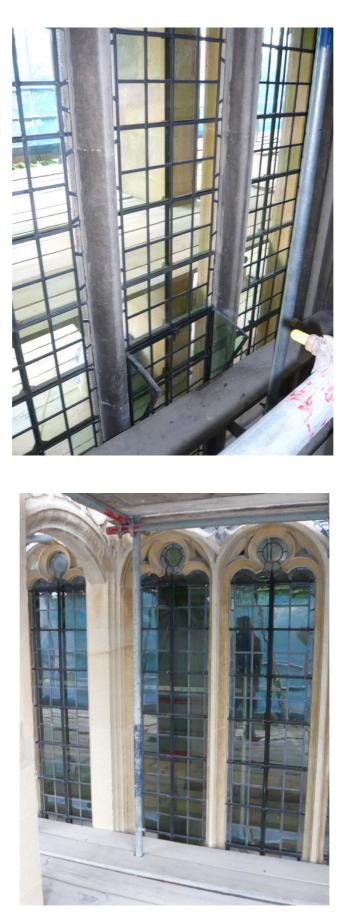
Figure 9 internal and external details of glazing

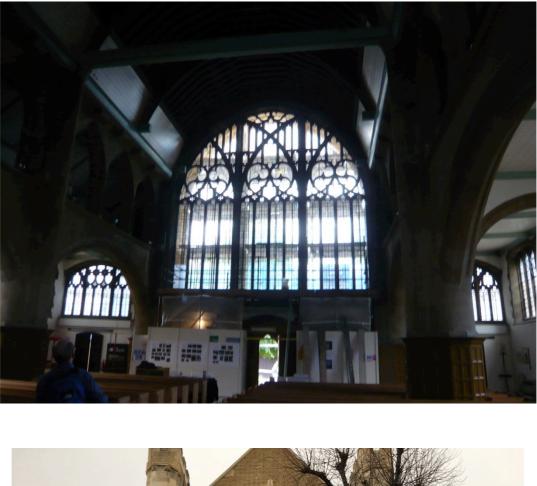
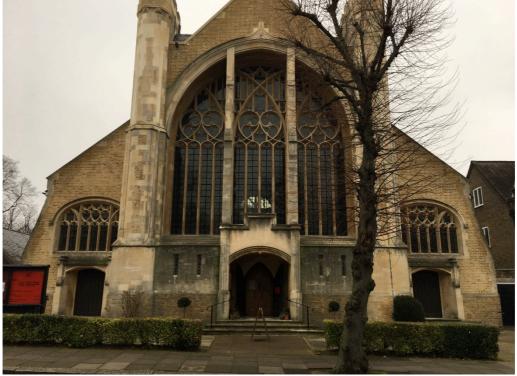
Figure 10 internal and external views of completed window.
